# Intel® Core™2 Extreme Processor QX9000<sup>Δ</sup> Series and Intel® Core™2 Quad Processor Q9000<sup>Δ</sup>, Q9000S<sup>Δ</sup>, Q8000<sup>Δ</sup> and Q8000S<sup>Δ</sup> Series

## **Specification Update**

*— on 45 nm Process in the 775-land LGA Package*

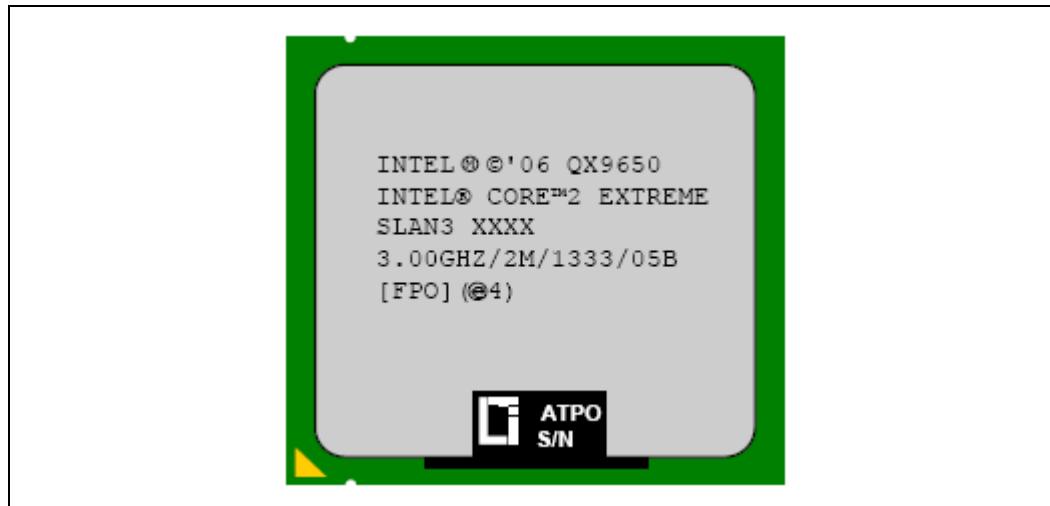
**Figure 1. Processor Top-Side Markings Example (Intel® Core™2 Extreme Processor QX9650)**

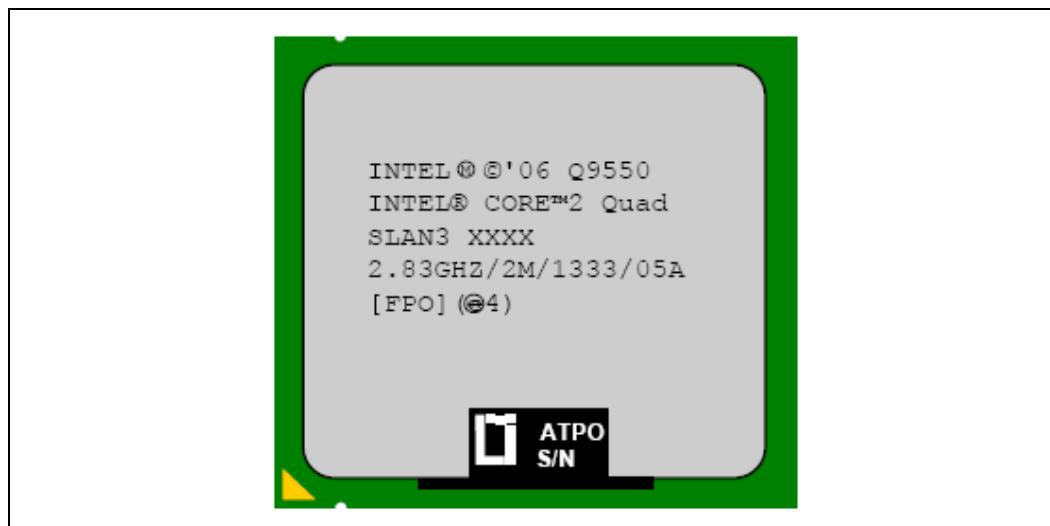
**Figure 2. Processor Top-Side Markings Example (Intel® Core™2 Quad Processor Q9000 Series)**
